Asset Management

Welcome to the Asset Management Program.

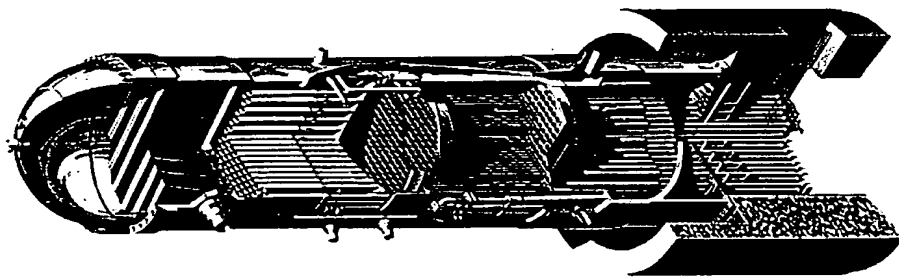
300 FIGURE - 4

You have chosen to review the Dresden 2 Asset Management Program.

Please choose one of the following internal components:

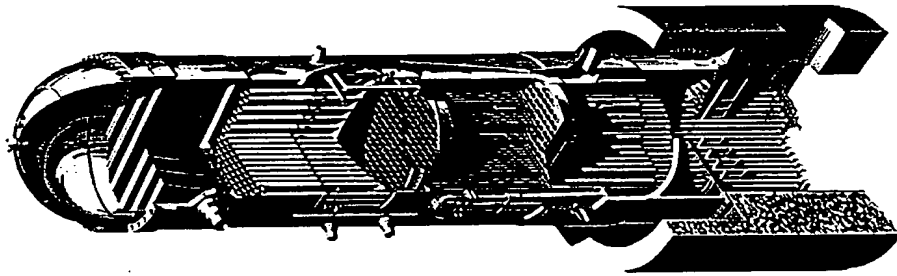
340 FIGURE - 5

- Core Spray Internal Piping ³⁴⁴
- Core Spray Sparger ³⁵⁰
- Lower Plenum - 354
- Shroud - 356 ³⁵⁸
- Shroud Support & Access Hole Cover ³⁶⁰
- Jet Pump Diffuser - 364
- Jet Pump Riser & Riser Brace ³⁶⁸ ³⁷⁰
- Jet Pump Inlet Mixer - 374
- Jet Pump Sensing Line - 378
- Top Guide - 380
- Core Plate - 384

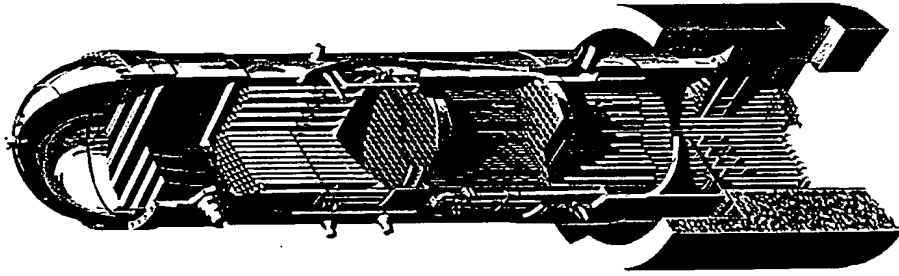
400 FIGURE - 6

You have chosen to review the La Salle 1
Asset Management Program.

Please choose one of the following internal
components:

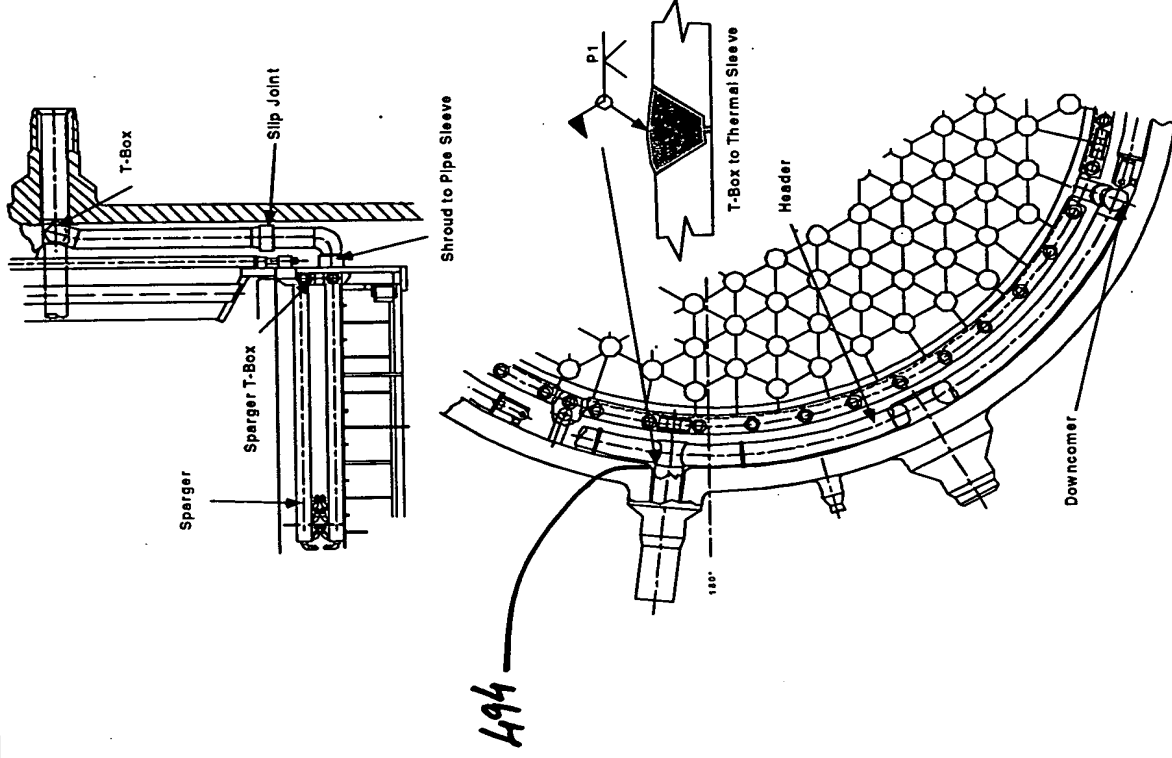
FIGURE - 8

Core Spray Internal Piping

There will be an active link on the weld callouts which takes the user to a table which gives a description of the weld and the susceptibility of the weld

The user can navigate to any of X figures having to do with this component. The current figure will be highlighted.
